SHOP NOTES King Midget Maintenance and Restoration

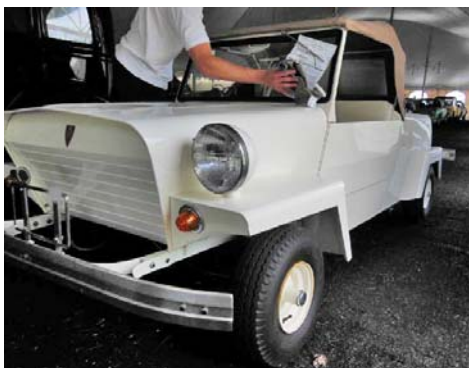
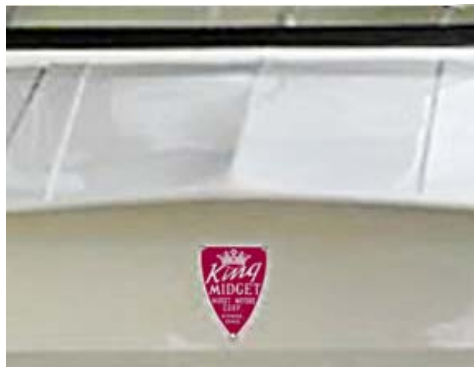
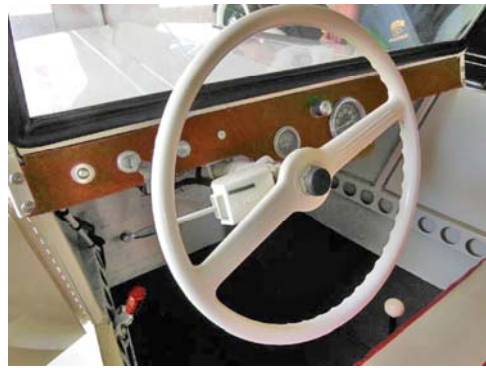
This car has its original hood and dash. Note the smooth curve of the top of the grille, with the crown behind it smoothed back to the center ridge. Hard to replicate. This is also an original dash, made of brown leather-textured hardboard, which deteriorated easily.

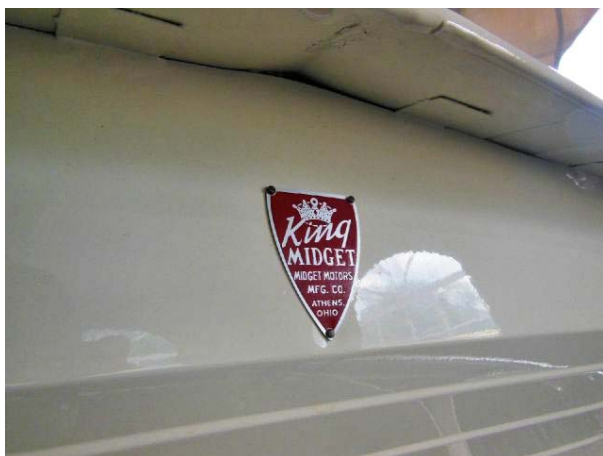
Tabs and spot welds secure the grille panel.

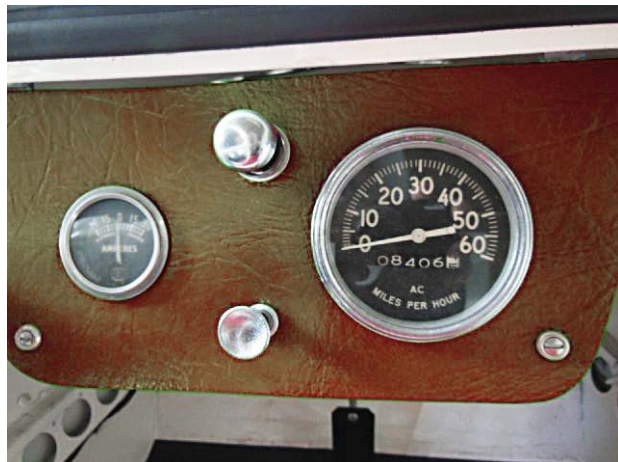
Detail of dashboard texture.

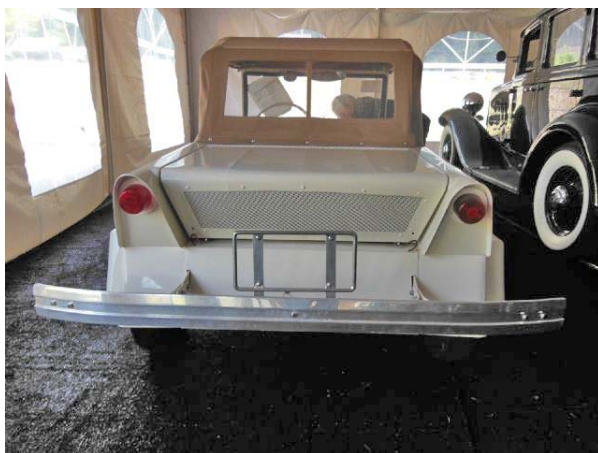
Original tops did not have center strip.

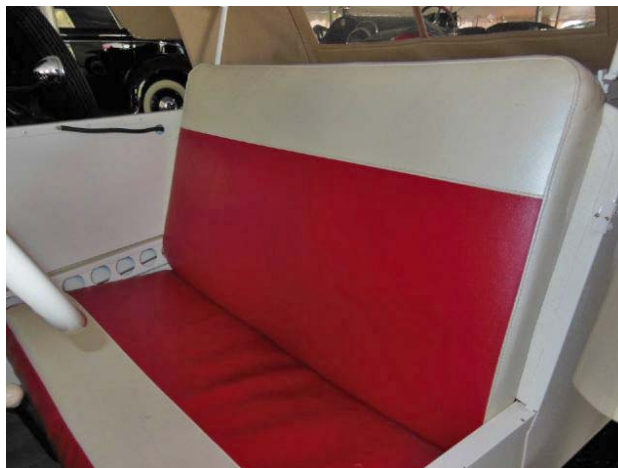
Correct seat colors and door pull. ■
